# DEFENSE RESEARCH LABORATORY

QUARTERLY PROGRESS REPORT No. 4  
UNDER CONTRACT NObsr-93125  
1 October - 31 December 1968

NAVAL SHIP SYSTEMS COMMAND Contract NObsr-93125, Project Serial No. SF1010318, Task 8048

### III. NEARFIELD BEARING AND RANGE ACCURACY CALIBRATION SYSTEM (NEFBRACS)

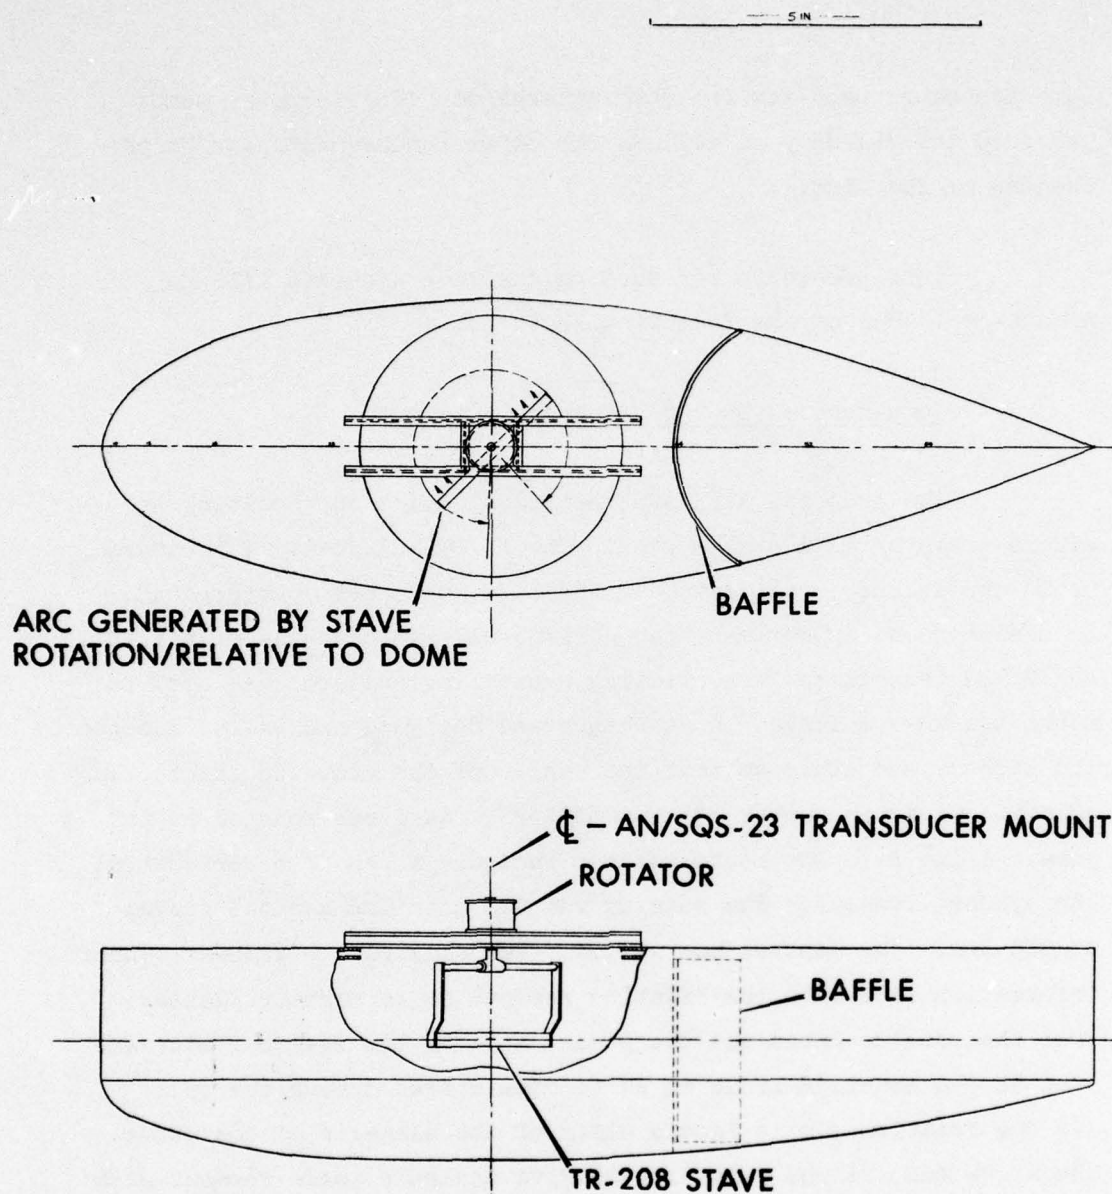
**FIGURE 1**  
**MOUNTING CONFIGURATION OF TR-208 STAVE**  
**AND ROTATOR ON AN/SQS-23 DOME**

The proposed NEFBRACS test plan called for mounting a single stave of TR-208 elements in the AN/SQS-23 dome. This stave would enable one to simulate sum and difference beam patterns and, in addition, to approximate the horizontal beam patterns of the full AN/SQS-23 transducer. An existing submersible rotator was used to mount the TR-208 stave. A structure was designed and built to support the rotator and stave so that the center of the stave would exactly coincide with the center of an AN/SQS-23 transducer mounted in the dome. (Fig. 1.) The stave rotator included a remote motor control and synchro readout. The rotator was designed for a total travel of 320 deg. The control box was modified slightly to provide synchro information either to the existing readout or to a polar plotter. Both the rotator cable and the power cable to the TR-208 stave were tied to the mounting frame so as to remain free during the full 320 deg rotation and to remain clear of the elements of the stave. The stave was aligned carefully to give accurate angle readout with respect to the dome.

Power for the stave was supplied by a CML 3 kVA amplifier. A switch was designed to provide three configurations of the TR-208 stave. When the stave was driven at high power (100 V rms drive), all 9 elements were connected in parallel. When the stave was used as a receiver, either all 9 elements were connected in series

(sum mode), or elements 1 through 4 were series wired in opposition to series-wired elements 6 through 9 (difference mode). These configurations were used to simulate the AN/SQS-23 in both the sum and difference receiving modes.

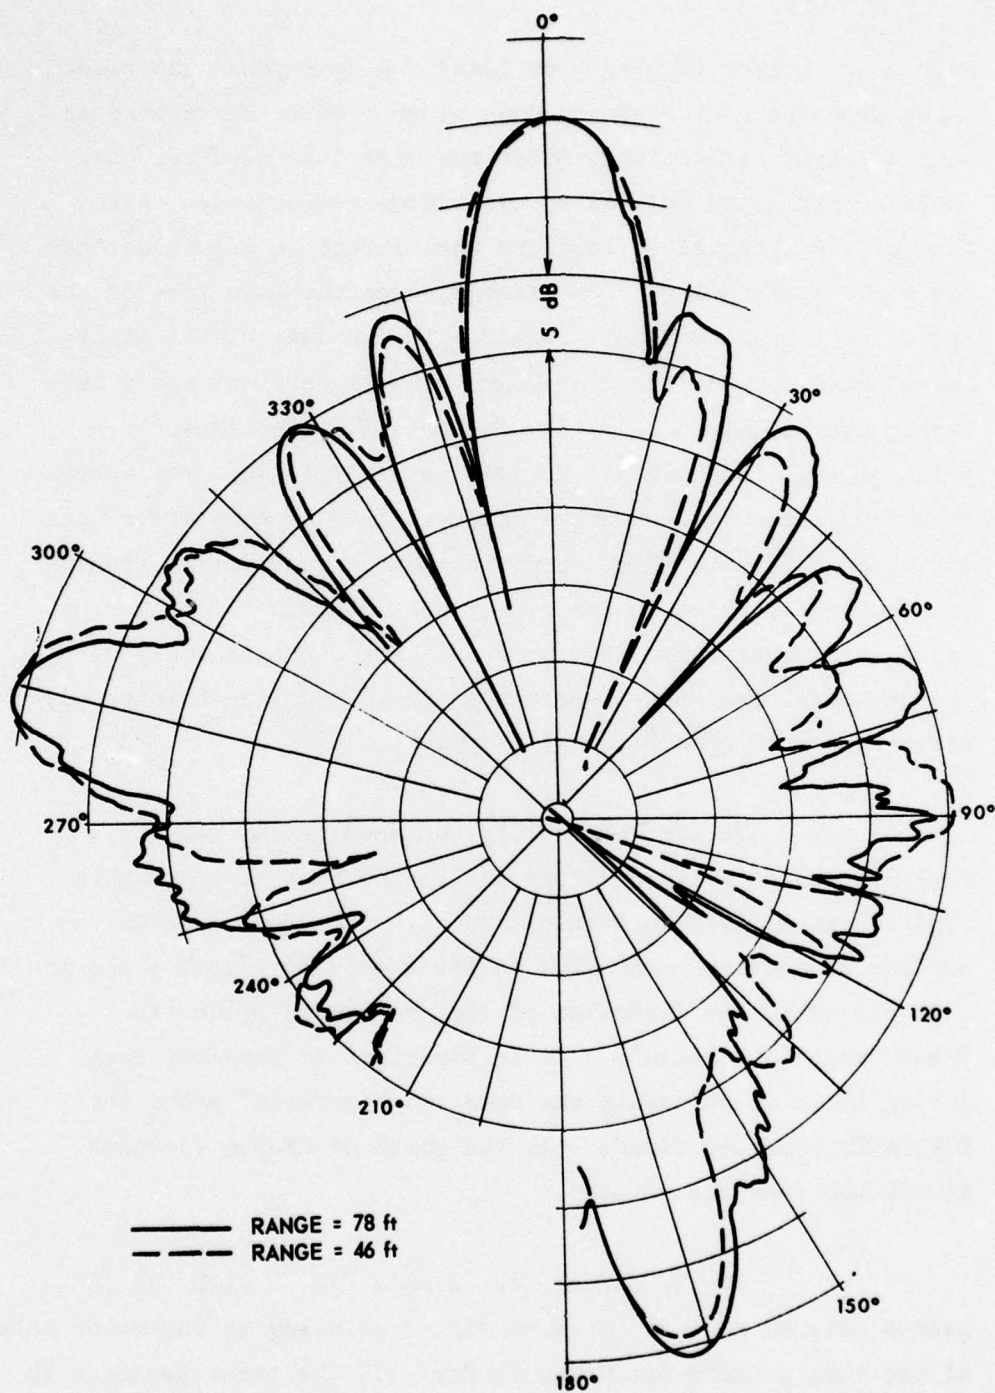
FIGURE 4  
COMPARISON OF STAVE TRANSMIT BEAM PATTERNS  
AT VARIOUS RANGES AT  $B_r = 084$

with short pulses (1.0 msec or less). A hydrophone was placed 24 ft from the center of the dome at Br = 085. There were as many as three reflections, after the direct-path pulse, that could be explained only as internal dome reflections. Also, some of the internal reflections were larger in magnitude than the direct-path pulse. For example, when the main lobe of the stave was turned towards the baffle in the dome with a minor lobe turned towards the hydrophone, the direct-path pulse had a relative amplitude of 0.053, followed 1.6 msec later by a pulse of amplitude 0.257. However, any reflection from surface or bottom could have occurred only 4.0 msec or more after the direct-path pulse. Thus, when considering long pulses from a transducer installed in the dome, such internal reflections would have to be taken into account. For the second set of measurements, long pulses were used to include these internal reflections. Figure 4 is one example.

measurement direction. The small outline of the transducer shown on Fig. 4 can be seen to point in this direction.

A striking indication of these patterns is that the dome is far from transparent. Two large spurious sidelobes exist at 165 deg and 285 deg. If the overlay is rotated so that the arrow points to the sidelobe at 285 deg on Fig. 4, the geometry is depicted at the instant this lobe was measured. It can readily be seen that the transducer was not pointing in the measurement direction but was pointed toward the baffle in the after part of the dome in approximately the correct manner to give a specular reflection in the measurement direction. For this reason, this lobe is blamed upon this internal dome reflection.

As the overlay is rotated so that the arrow points to the other spurious side lobe at 165 deg, it can readily be seen why reflected acoustic energy off the opposite side of the dome is construed to be the source of this high side lobe.

To further clarify the measurement geometry, Fig. 3 (located in an envelope inside the back cover of this report) can be used to overlay Fig. 4. The overlay shows the outline of the dome and shows an arrow (at 084 relative bearing) that points in the direction of the "farfield" probe (the "measurement direction"). It is important to remember that during these measurements the dome and "farfield" probe (or NEFBRACS) remained fixed; only the stave of TR-208 elements inside the dome was rotated.

If one places Fig. 3 upon Fig. 4 with the center points aligned and the arrow on Fig. 3 pointing to the major lobe of the beam pattern (at 0 deg on Fig. 4), the exact geometry is depicted at the instant the peak of the major lobe passed the

requirement (10D) would imply a distance of 45 ft. Figure 4 demonstrates that the presence of internal dome reflections at  $Br = 084$  requires a somewhat larger distance to obtain farfield beam patterns since there is an appreciable difference between the beam patterns at 46 ft and 78 ft. Even though the water depth increased in this direction (Fig. 2), the presence of surface reflections and the pulse length required to include internal dome reflections limited test distances to 78 ft. During the next quarter, the STEP Barge will be moved to much deeper water so that larger test distances may be used to determine experimentally the farfield boundary.

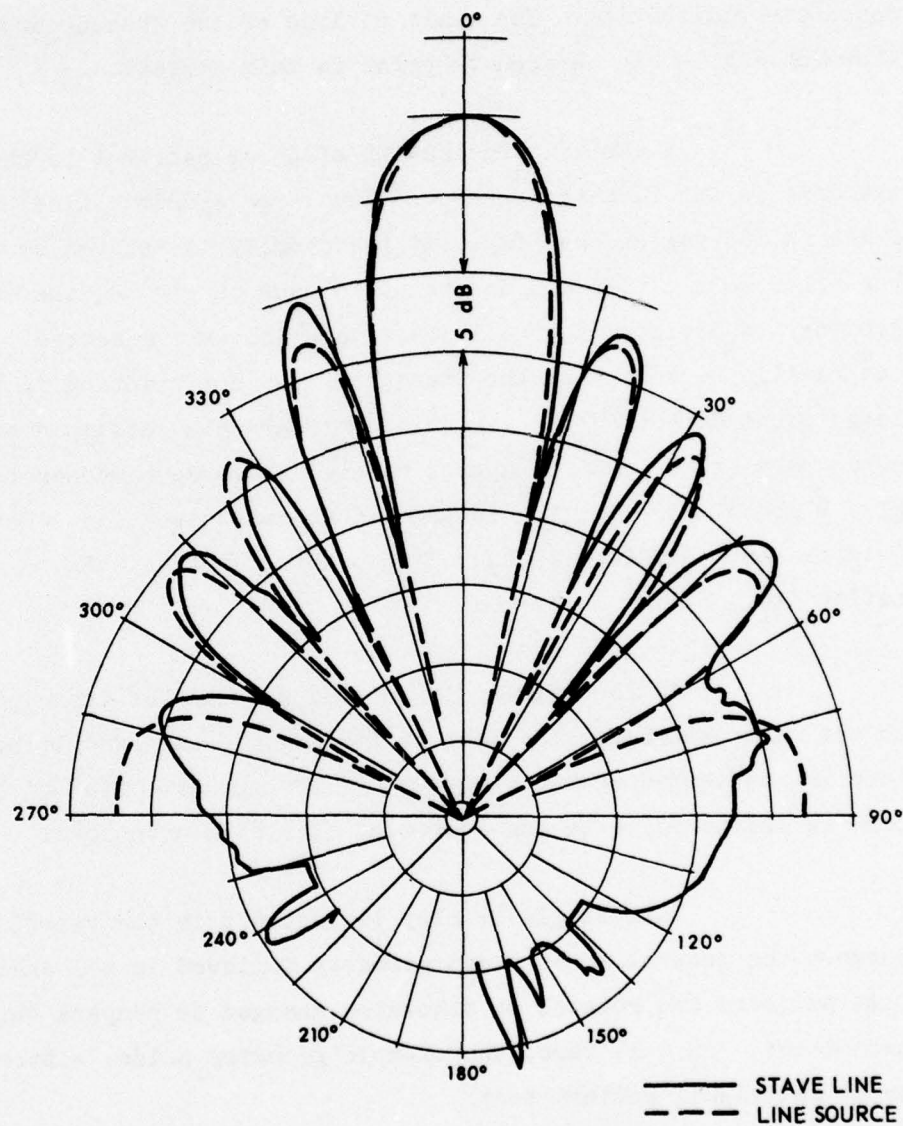
FIGURE 5  
COMPARISON OF STAVE TRANSMIT BEAM PATTERN  
(BEFORE DOME INTERNAL REFLECTIONS)  
AND THEORETICAL LINE SOURCE

3. One polar beam pattern taken at this time proved invaluable because it was taken at a short enough delay time so as not to include internal reflections of the dome (Fig. 5), and it emphasizes the effect of the dome on the beam pattern of the stove (Fig. 6). This beam pattern was transferred from Brüel and Kjaer polar paper to the same scale and normalization

as the second set of measurements. The projector was 100 ft from the dome at about  $Br = 0.78$ , and the receive gate was 1.0 msec after the arrival of the direct-path pulse. Note that the beam pattern compares favorably with the theoretical pattern of a line source of length 4.5 wavelengths, of which the stave should be a close approximation.

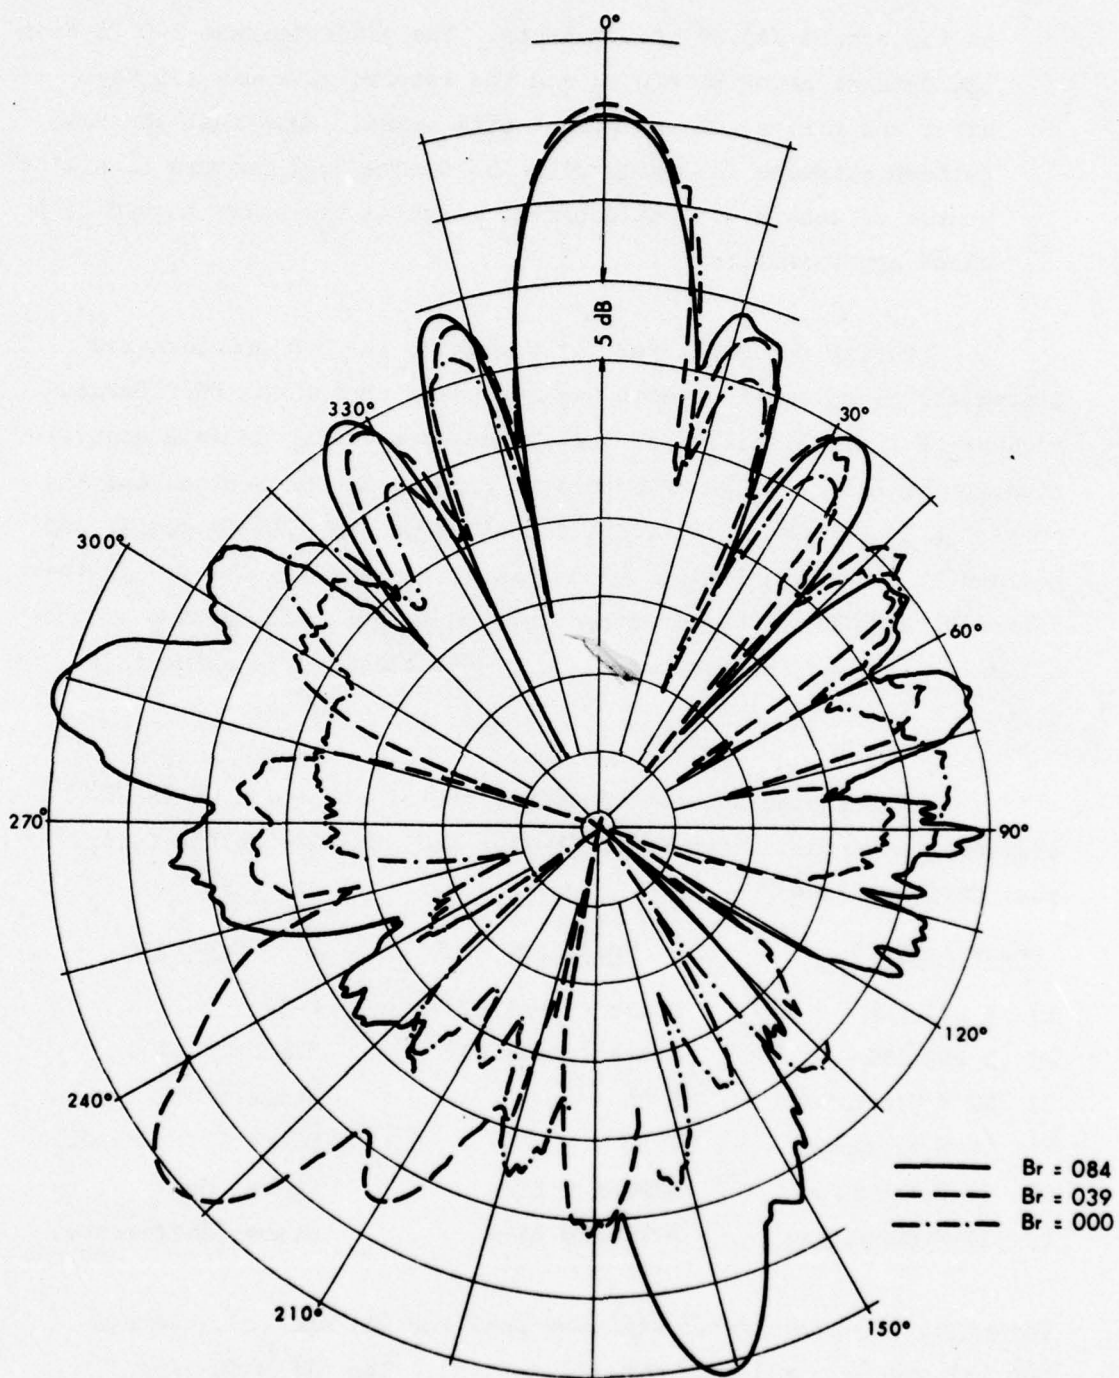
FIGURE 6  
COMPARISON OF STAVE TRANSMIT BEAM PATTERNS  
AT VARIOUS RELATIVE BEARINGS  
WITH RECEIVER IN "FARFIELD"

Figure 6 compares the beam patterns of stave-plus-dome at different bearings with a probe at approximately the same distance from the center of the dome. It can be seen that the dome, by its internal reflections, causes beam patterns to be a function of bearing. Note the large -10 dB lobes at 165 deg, 230 deg, and 285 deg on the plot. These lobes are due to internal dome reflections for the probe angles other than  $Br = 000$ .

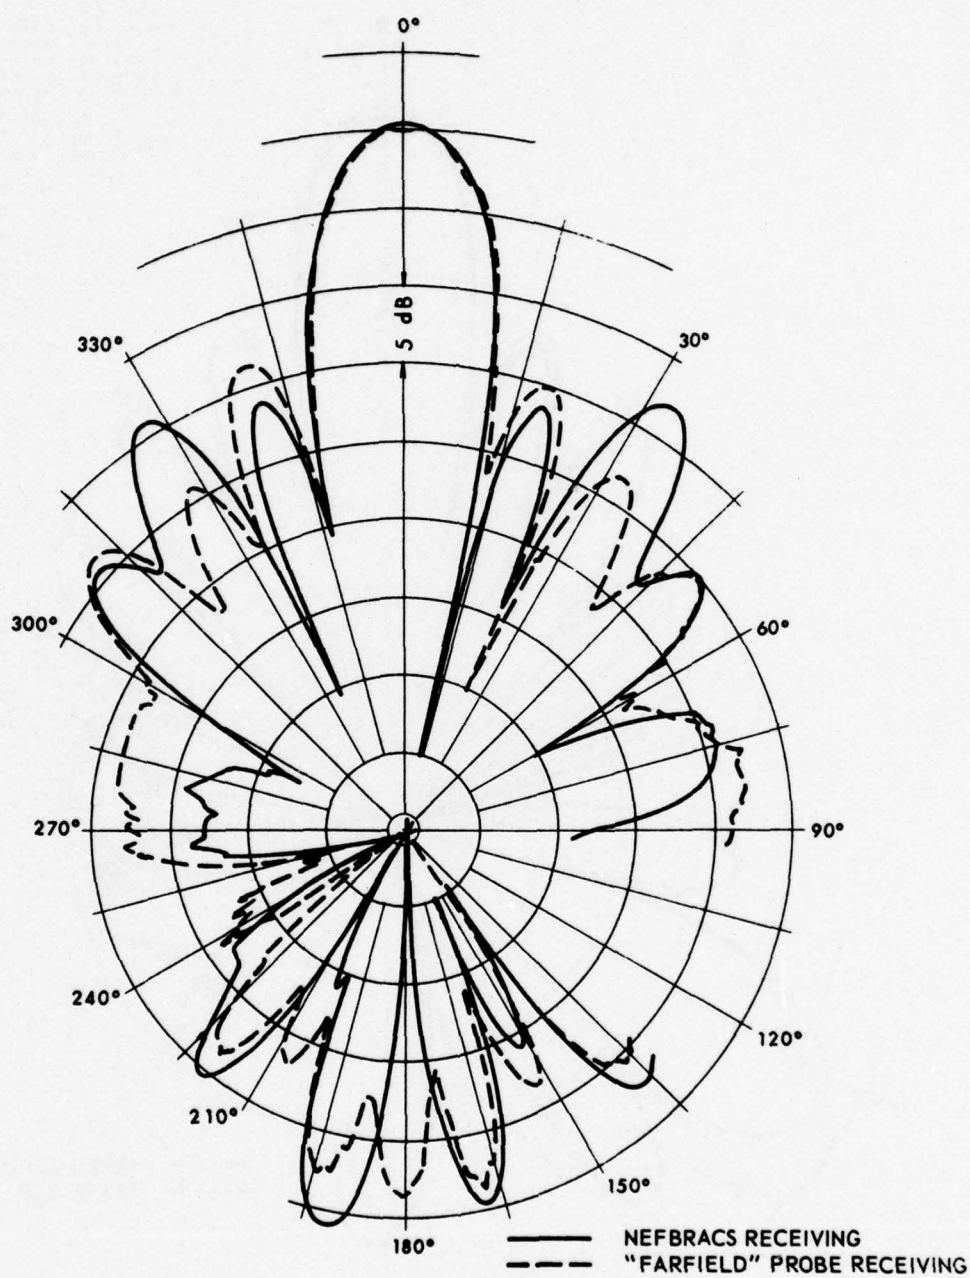
FIGURE 7  
 COMPARISON OF STAVE TRANSMIT BEAM PATTERNS  
 AT Br = 000

It was expected that the NEFBRACS and "farfield" beam patterns would differ least at  $Br = 000$  because the width of the dome when viewed from this bearing is minimum. Consequently, the pattern at a distance of 70 ft would be closer to the true farfield pattern of the stave-plus-dome than at other angles. However, the comparison is poor (Fig. 7). Since the horizontal stave has a large vertical beamwidth (about 120 deg), the NEFBRACS line may have received reflections from the bottom of the dome, because at this bearing the dome extends more than half the distance to the NEFBRACS line. With a full SQS-23 transducer array in the dome, the comparison might be better since the active staves of the transducer would be closer to the forward end and the vertical beamwidth would be much narrower. Support for this conjecture is found in the comparison at  $Br = 039$  (Fig. 8). The dome at this bearing extends less than half the distance to the NEFBRACS line and the beam patterns compare well. The NEFBRACS and "farfield" beam pattern comparison at  $Br = 084$  (Fig. 9) agree fairly well except around 280 deg on the plot. It is thought that the measured "farfield" beam pattern at  $Br = 084$  is not truly farfield, as was pointed out previously (also see Fig. 4), so that future tests will be necessary.

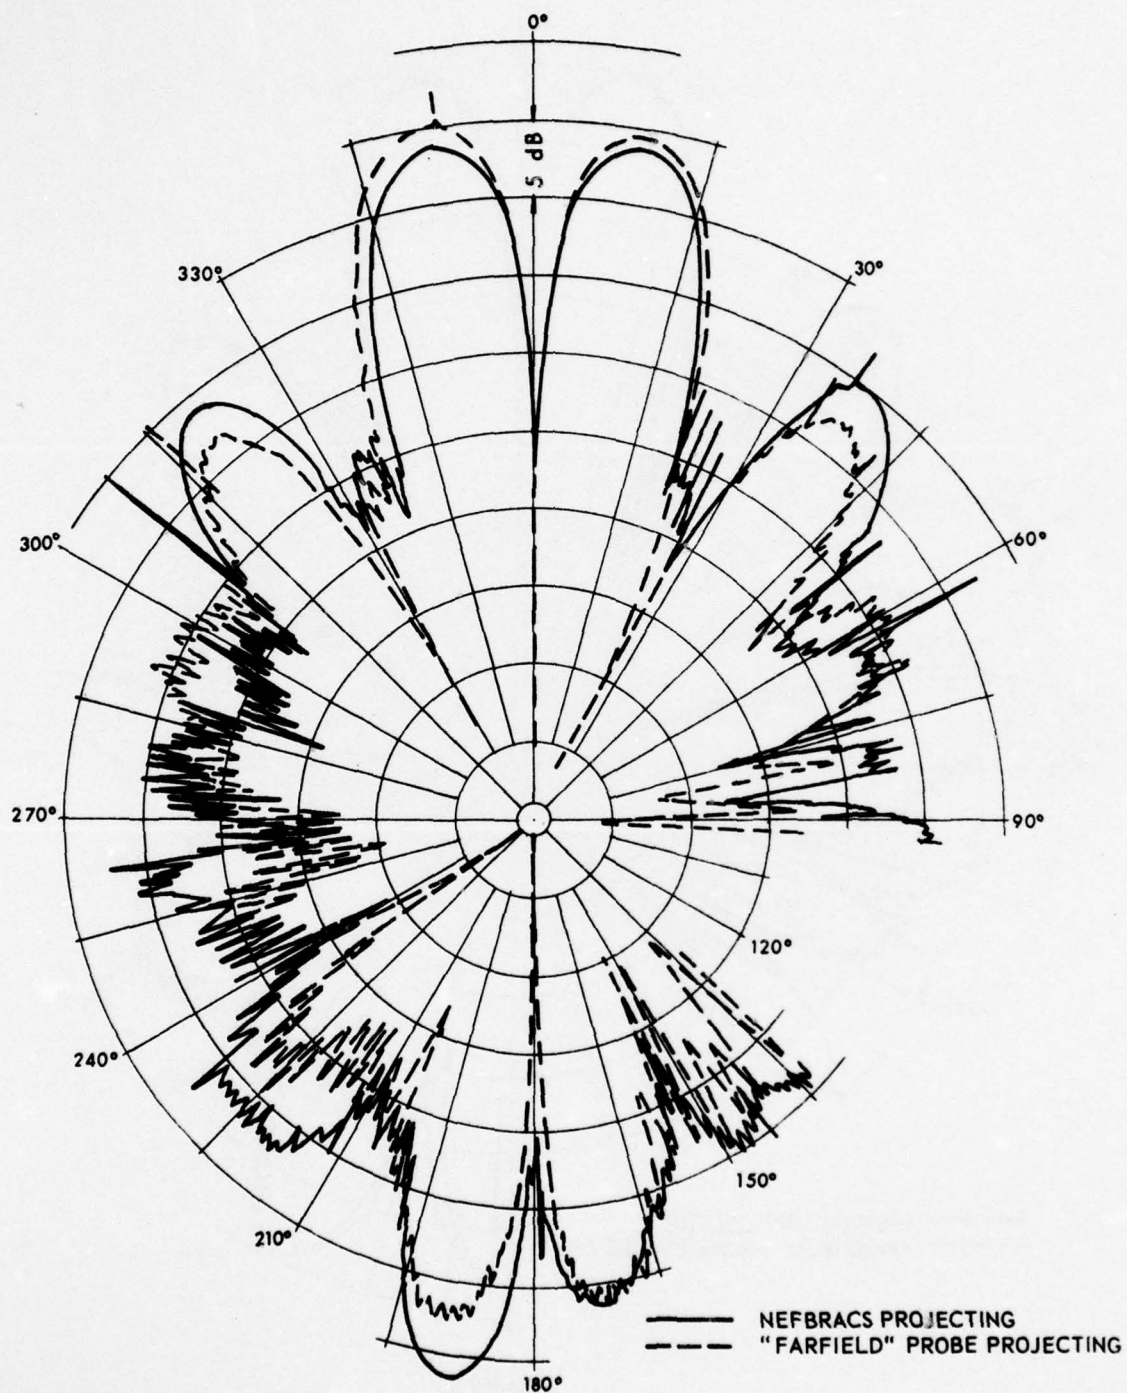
FIGURE 10  
COMPARISON OF STAVE RECEIVE (DIFFERENCE)  
BEAM PATTERNS AT  $B_r = 000$

Figures 10 and 11 are comparisons at  $Br = 000$  and  $Br = 084$  of the stave in receiving (difference mode). There were no "difference" beam patterns taken with the NEFBRACS line at  $Br = 039$  because of bad weather and the resultant increase of noise in the water. The beam patterns in the second data set were in the chronological order of  $Br = 084$ ,  $Br = 039$ , and  $Br = 000$ . The reason for the odd magnitudes of the first two bearings is that initially the center line of the dome was assumed to be parallel to the edge of the STEP Barge. But since both the stave rotator readout and the NEFBRACS angle readout had been calibrated to read in relative bearing, it was decided that the center line of the dome was oriented  $5.7$  deg off the "center line" of the STEP Barge. Consequently, for the last of the runs the probe was initially positioned to give a reading of  $Br = 000$ . When the NEFBRACS line was rotated into position, its reading was also  $Br = 000$  and, as can be seen in Fig. 10, the nulls coincide quite well.
